**Flood Control Project Maintenance
Levee Inspections**

Maintenance Issue Types Only, Levee Inspection Report By Mile - Spring 2017

Sutter Maintenance Yard Maintenance Area 0007

Waterway	Bank	Unit Miles	Inspection Start/End	Inspector
Unit No. 01 Feather River	Right	11.90	03/23/2017 03/23/2017	Sterling York

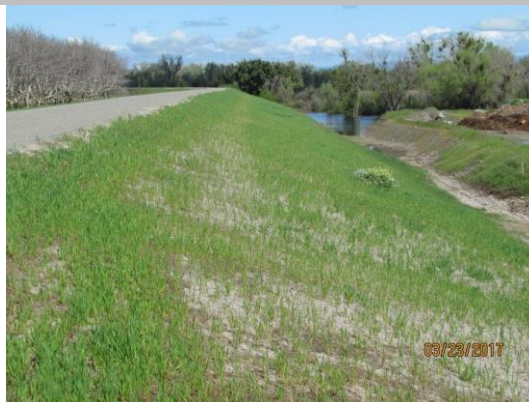
Photo 1 of 1 : SP_2017_MA0007_200_44_20170327_00129.jpg

View of well maintained vegetation, water side looking upstream. Spring 2017.

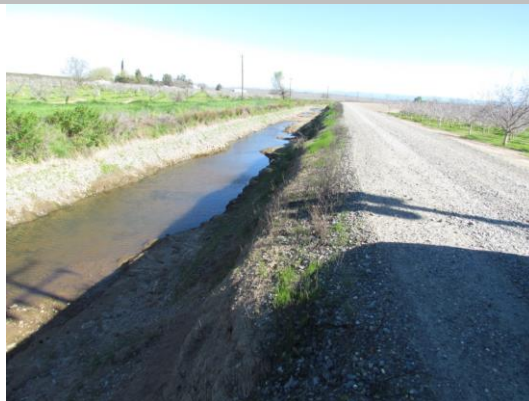
Photo 2 of 2 : SP_2017_MA0007_200_42_20170316_00004.jpg

This photo was taken from the levee crown facing north looking at the erosion along the landward levee slope due to an agricultural ditch. Spring 2014.

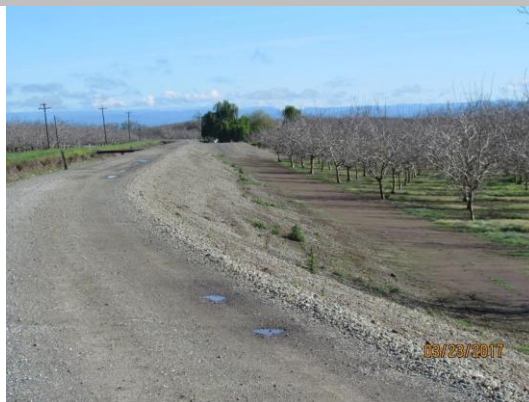
Photo 1 of 1 : SP_2017_MA0007_200_41_20170327_00117.jpg

LM Start	0.12	Rating **	A	Issue No.	41
LM End	1.02	Issue Type +	Ma	Location *	WS
Category	Earthen Levee			GPS Latitude/Longitude	
				Start	End
Item	Vegetation			39.312567 °	39.324458 °
				-121.636964 °	-121.631803 °
DWR ID	DWR_MA0007_01_s _ 2017_41				
Comment Code					
V1 : Control annual grass and weeds on the levee slopes and easements.					
Inspector Comment					
View of controlled vegetation.

View of controlled vegetation looking upstream on the water side. Spring 2017.

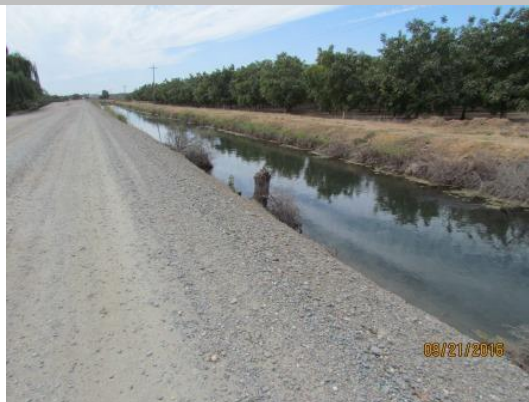
Photo 1 of 1 : SP_2017_MA0007_200_72_20170316_00018.jpg

LM Start	0.44	Rating **	U	Issue No.	72
LM End	0.44	Issue Type +	Ma	Location *	LS
Category	Earthen Levee			GPS Latitude/Longitude	
				Start	End
Item	Trim / Thin Trees			39.316527 °	39.316527 °
				-121.633800 °	-121.633800 °
DWR ID	DWR_MA0007_01_f_2016_72				
Comment Code					
T5 : Tree stumps.					
Inspector Comment					
The decomposing stump is next to the canal on the landside and needs to be removed.

View of a stump on the landside slope looking downstream. This stump is next to the canal on the landside and is decomposing and needs to be removed.

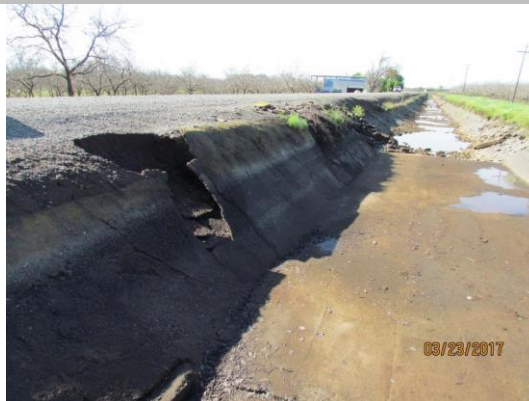
Photo 1 of 2 : SP_2017_MA0007_200_68_20170327_00119.jpg

Inspection Spring 2017, erosion continues to get worse.

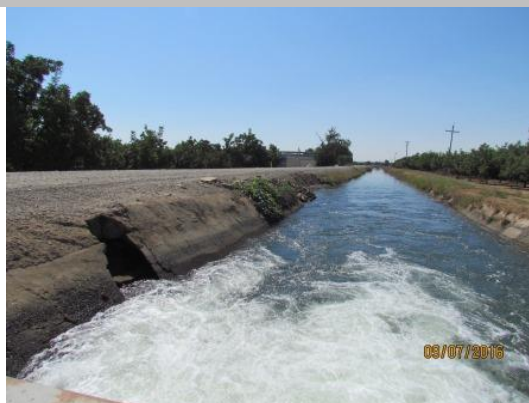
Photo 2 of 2 : SP_2017_MA0007_200_68_20170316_00015.jpg

LM Start	0.56	Rating **	U	Issue No.	68 (cont)
LM End	0.56	Issue Type +	Ma	Location *	LS

View of eroding slope due to irrigation ditch on landside slope, looking downstream. Fall 2016.

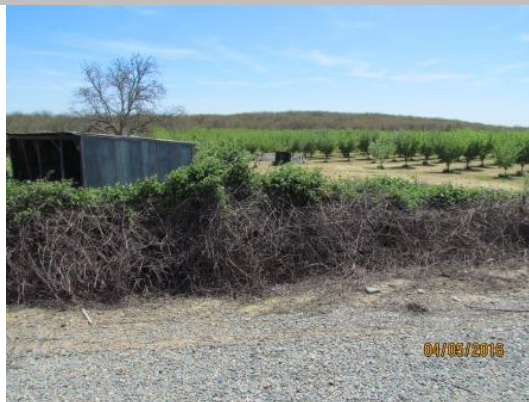
Photo 1 of 1 : SP_2017_MA0007_200_67_20170316_00014.jpg

LM Start	0.92	Rating **	A/W	Issue No.	67
LM End	0.92	Issue Type +	Ma	Location *	LS
Category	Earthen Levee			GPS Latitude/Longitude	
				Start	End
Item	Vegetation			39.323118 °	39.323118 °
				-121.632205 °	-121.632205 °
DWR ID	DWR_MA0007_01_s _ 2016_67				
Comment Code					
V2 : Remove the wild growth other than native grasses from the levee slopes.					
Inspector Comment

View of landside toe vegetation looking downstream.

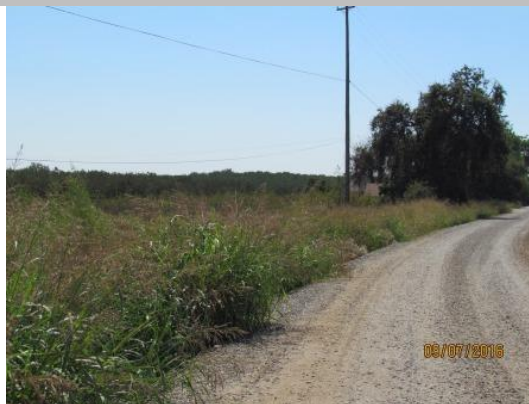
Photo 1 of 1 : SP_2017_MA0007_200_71_20170316_00017.jpg

View of waterside annual grasses that need to be maintained. Looking downstream.

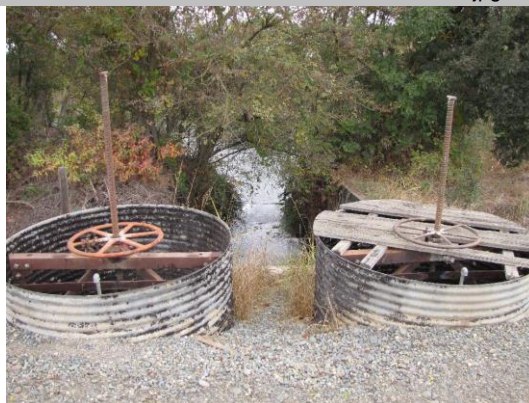
Photo 2 of 3 : UCIP_SP_2017_47836_65813.jpg

FS_ID:47836
DS_ID:16926
EP_NO: N/A
Repair Type: Non-Urgent
Crossing Status: Found
UCIP Comments: 5/16/2016 Feather River West Levee Improvement Project--Levee currently under construction.6/10/2015 Debris still present in risers and pipes were not replaced with the SBFCA project.12/29/2014 Same as last inspection.5/19/2014 Same as last inspection.11/6/2013 Same as last inspection.5/13/2013 SBFCA project recommends replacing in accordance with title 23.5/7/2013 Same debris issue as last inspection. Recommend repairing top cover to prevent falls. Wheel to open gate chained and locked so could not verify gate operation.10/31/2012 Debris inside riser could prevent slide gate from closing. This crossing was listed in the USACE Periodic Inspections as ID# USACE_CESPK_MA07_2010_a_0060 however, no issues noted. FIELD_STRUCT_DESC: 1 of 2: 60-inch drainage pipe through the levee, 12.5 feet below the crown. Slide gates in 78-inch corrugated metal pipe (CMP) wells on the waterside (WS) slope. Concrete bulkhead on both WS and landside (LS) ends. Reinforced concrete spillway an the WS end. [Additional Reference(s): DWR Levee Log, 2005. USACE Sacramento O&M Manual 152, March 1957 (Station 1+90)]

78-inch CMP risers located on WS slope. Upstream riser (far left) missing riser cover. Reinforced concrete spillway also located on WS end.

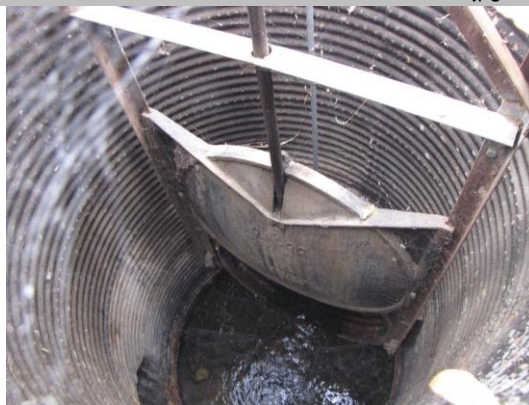
Photo 3 of 3 : UCIP_SP_2017_47836_65812.jpg

View inside of CMP riser with slide gate.

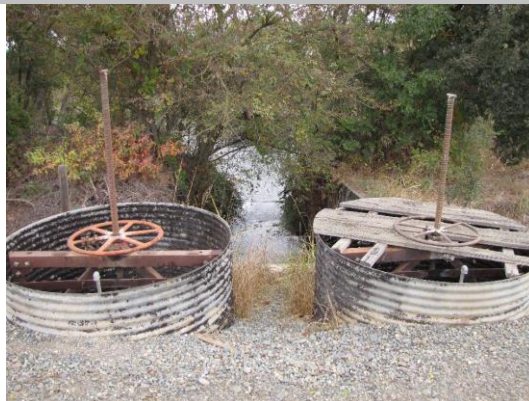
Photo 2 of 3 : UCIP_SP_2017_47837_65819.jpg

FS_ID:47837
 DS_ID:17011
 EP_NO: N/A
 Repair Type: Non-Urgent
 Crossing Status: Found
 UCIP Comments: 5/16/2016 Feather River West Levee Improvement Project--Levee currently under construction.6/10/2015 Debris still present inside riser and pipe was not replaced with the SBFCA project.12/29/2014 Same as last inspection.5/19/2014 Same as last inspection.11/6/2013 Same as last inspection.5/13/2013 SBFCA project recommends replacing in accordance with title 23.5/7/2013 Same as last inspection. Recommend constructing cover to prevent falls. Wheel to operate gate chained and locked so gate operation could not be verified.10/31/2012 no cover; debris inside riser could prevent slide gate from closing. This crossing was listed in the USACE Periodic Inspections as ID# USACE_CESPK_MA07_2010_a_0060 however, no issues noted. FIELD_STRUCT_DESC: 2 of 2: 60-inch drainage pipe through the levee, 12.5 feet below the crown. Slide gates in 78-inch corrugated metal pipe (CMP) wells on the waterside (WS) slope. Concrete bulkhead on both WS and landside (LS) ends. Reinforced concrete spillway on the WS end. [Additional Reference(s): DWR Levee Log, 2005. USACE Sacramento O&M Manual 152, March 1957 (Station 1+90)]

78-inch CMP risers located on WS slope. Upstream riser (far left) missing riser cover. Reinforced concrete spillway also located on WS end.

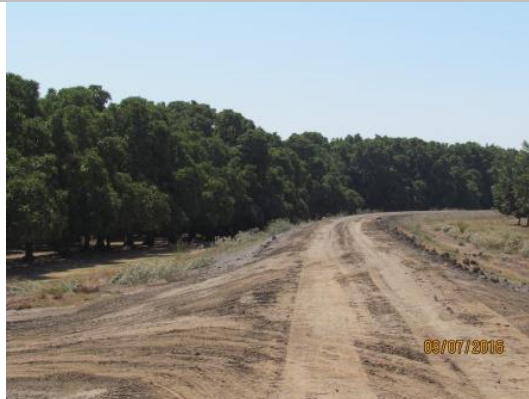
Photo 1 of 2 : SP_2017_MA0007_200_62_20170316_00013.jpg

View of levee that has been brought back to design elevation but still needs the aggregate base placed. Looking downstream. Fall 2016.

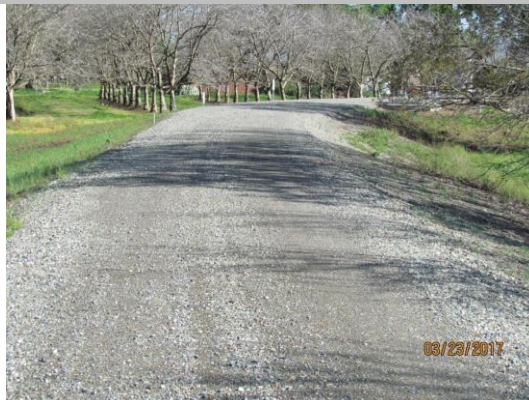
Photo 2 of 2 : SP_2017_MA0007_200_62_20170327_00120.jpg

LM Start	1.82	Rating **	A	Issue No.	62 (cont)
LM End	2.53	Issue Type +	Ma	Location *	CR

View of levee that has been brought back to design elevation and the aggregate base placed. Looking upstream. Spring 2017.

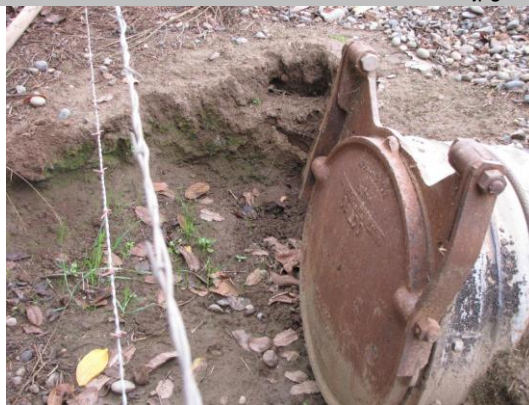
Photo 2 of 3 : UCIP_SP_2017_47975_65824.jpg

View of flap gate located on WS toe.

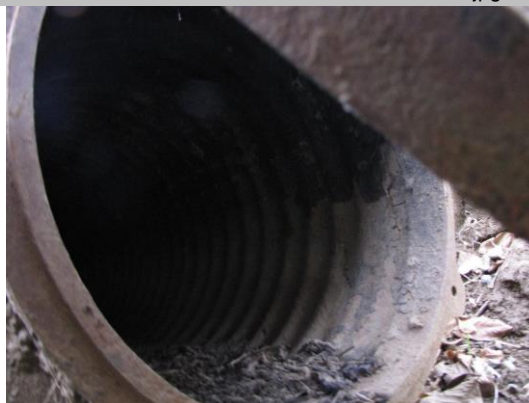
Photo 3 of 3 : UCIP_SP_2017_47975_65826.jpg

FS_ID:47975
DS_ID:16925
EP_NO: 18708
Repair Type: No Action Needed
Crossing Status: Found
UCIP Comments: 5/16/2016 Feather River West Levee Improvement Project--Levee currently under construction. Crossing, referenced as STA 1777+00, will be removed and replaced as indicated in the project Plans for Construction of Feather River West Levee Project, Project Area A, Feather River West Levee Improvement Plans, Sta 1765+00 to 2368+26, Volume 3 of 5.6/10/2015 Pipe appears to be in good condition. No noticeable issues to report.12/29/2014 Same as last inspection.5/19/2014 Same as last inspection.11/6/2013 Same as last inspection.5/13/2013 SBFCA project recommends replacing in accordance with title 23.10/31/2012 WS gate appears to be working. This crossing was listed in the USACE Periodic Inspections as ID# USACE_CESPK_MA07_2010_a_0062 for broken flap gate on WS and half blocked by soil/vegetation on LS.

Crossing appears to be tar coated inside, unable to confirm damage to wall.

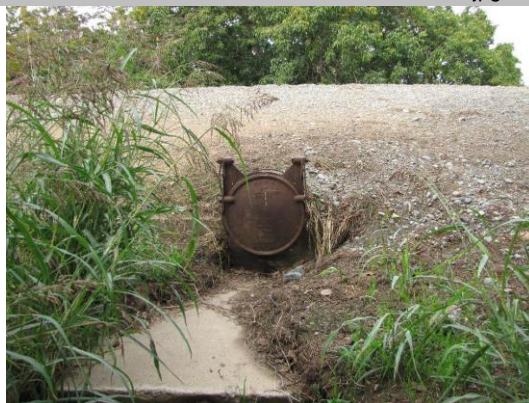
Photo 2 of 3 : UCIP_SP_2017_47976_65832.jpg

FS_ID:47976
DS_ID:16924
EP_NO: 18709
Repair Type: No Action Needed
Crossing Status: Found
UCIP Comments: 5/16/2016 Feather River West Levee Improvement Project--Levee currently under construction. Crossing, referenced as STA 1785+24, will be removed and replaced as indicated in the project Plans for Construction of Feather River West Levee Project, Project Area A, Feather River West Levee Improvement Plans, Sta 1765+00 to 2368+26, Volume 3 of 5.6/10/2015 Pipe appears in good condition. No noticeable issues to report.12/29/2014 Same as last inspection.5/19/2014 Same as last inspection.11/6/2013 Same as last inspection.5/13/2013 SBFCA project recommends replacing in accordance with title 23.5/7/2013 Periodic inspection issue has been resolved and gate is clear to operate normally.10/31/2012 This crossing was listed in the USACE Periodic Inspections as ID# USACE_CESPK_MA07_2010_a_0070 for inoperable flap gate filled with gravel.

Crossing with concrete apron and flap gate located on WS end.

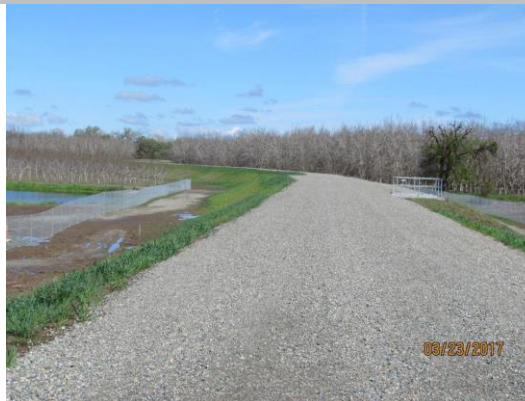
Photo 1 of 2 : SP_2017_MA0007_200_61_20170327_00121.jpg

LM Start	2.53	Rating **	A/W	Issue No.	61
LM End	3.33	Issue Type +	Ma	Location *	CR
Category	Earthen Levee			GPS Latitude/Longitude	
				Start	End
Item	Crown Surface / Depressions / Rutting			39.345322 °	39.354627 °
				-121.629604 °	-121.635530 °
DWR ID	DWR_MA0007_01_f_2016_61				
Comment Code					
C2 : Repair depressions or ruts in the crown or slope.					
Inspector Comment					
This section of levee is back to design elevation and crown rocked.

View of the levee that has been brought back to design elevation and rocked, looking upstream. Spring 2017.

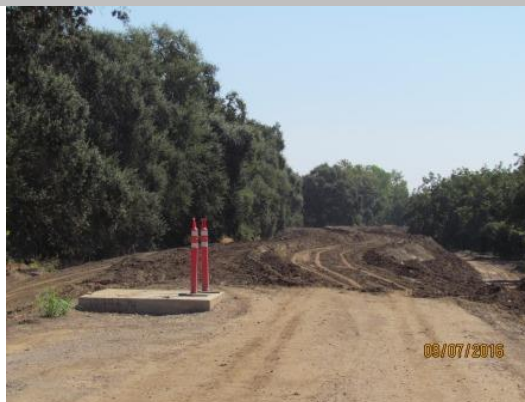
Photo 2 of 2 : SP_2017_MA0007_200_61_20170316_00012.jpg

View of the levee that is currently under construction and has been degraded and is being brought back to design elevation, looking downstream. Fall 2016.

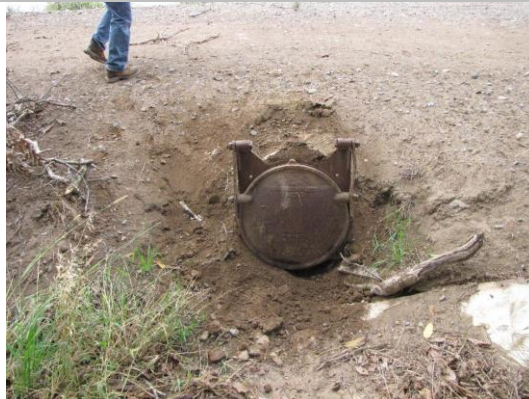
Photo 2 of 3 : UCIP_SP_2017_48000_65852.jpg

Comment Code					
Inspector Comment					
FS_ID:48000 DS_ID:16910 EP_NO: N/A Repair Type: Non-Urgent Crossing Status: Found UCIP Comments: 5/16/2016 Feather River West Levee Improvement Project--Levee currently under construction. Crossing, referenced as STA 1809+65, will be removed and replaced as indicated in the project Plans for Construction of Feather River West Levee Project, Project Area A, Feather River West Levee Improvement Plans, Sta 1765+00 to 2368+26, Volume 3 of 5.6/10/2015 Pipe appears in good condition. No noticeable issues to report.12/29/2014 Same as last inspection.5/19/2014 Same as last inspection.11/6/2013 Same as last inspection.5/13/2013 SBFCa project recommends replacing in accordance with title 23.5/7/2013 WS sediment blocking gate has been cleared so gate can operate normally. Recommend clearing sediment buildup at mouth of pipe on LS.10/31/2012 WS headwall may be present not visible due to soil cover. Sediment build up on LS headwall--clear. This crossing was listed in the USACE Periodic Inspections as ID# USACE_CESPK_MA07_2010_a_0083 for inoperable gate. FIELD_STRUCT_DESC: 24-inch corrugated metal pipe through the levee, 6.7 feet below the crown. Flap gate on the waterside (WS) end. Concrete headwall at both WS and landside (LS) toes. (USACE O&M Manual, 1957) [Additional Reference(s): DWR Levee Log, 2005. USACE Sacramento O&M Manual 152, March 1957 (Station 44+50)] FS Date: 5/16/2016 10:25:00 AM

View of flap gate located on WS.

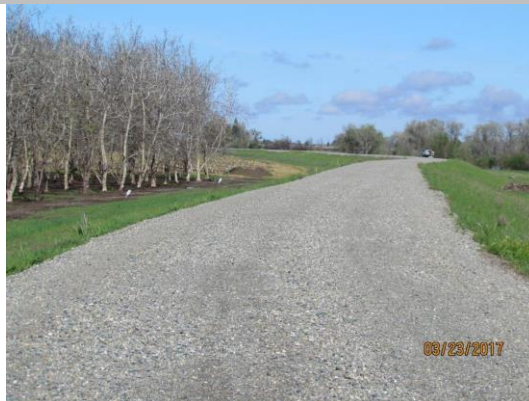
Photo 1 of 2 : SP_2017_MA0007_200_60_20170327_00122.jpg

View of levee that has been brought back to design elevation and the aggregate base placed. Looking upstream. Spring 2017

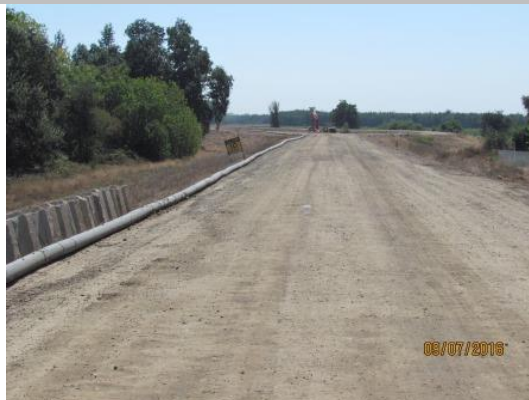
Photo 2 of 2 : SP_2017_MA0007_200_60_20170316_00011.jpg

View of levee that has been brought back to design elevation but still needs the aggregate base placed. Looking down stream. Fall 2016.

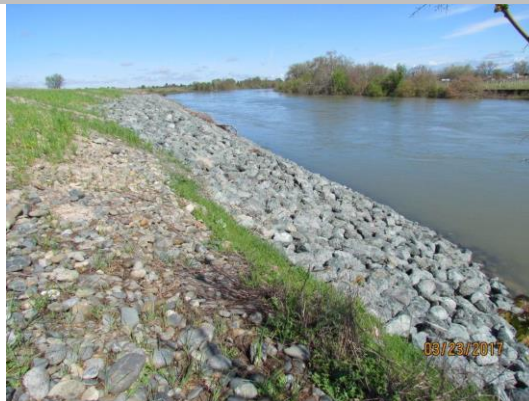
Photo 1 of 1 : SP_2017_MA0007_200_6_20170327_00123.jpg

Erosion repair photo Spring 2017.

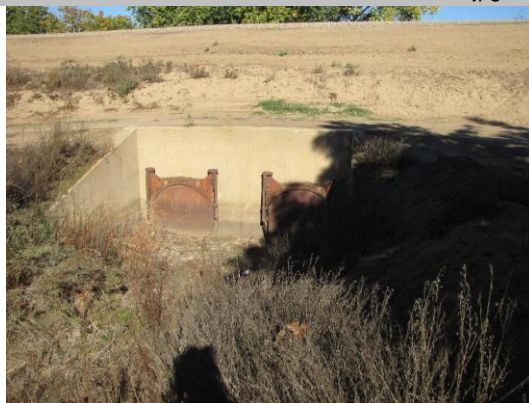
Photo 2 of 3 : UCIP_SP_2017_48005_65905.jpg

View of headwall structure on WS. Sediment built up

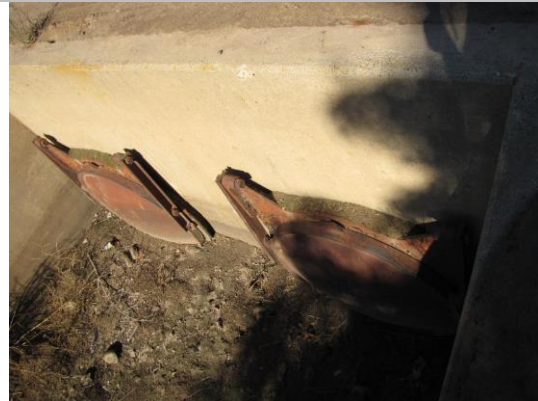
Photo 3 of 3 : UCIP_SP_2017_48005_65908.jpg

Sediment blocking gates on WS.

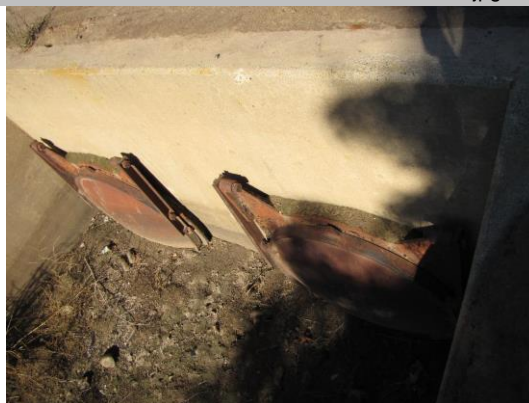
Photo 3 of 3 : UCIP_SP_2017_48006_65909.jpg

WS--Sediment build up against flap gates.

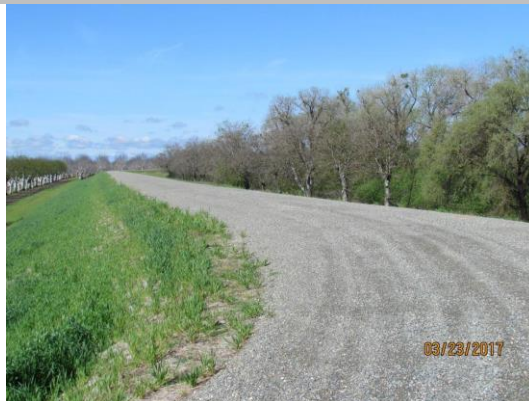
Photo 1 of 2 : SP_2017_MA0007_200_54_20170327_00124.jpg

View of this portion of the levee that has been degraded and is being brought back to design elevation and rocked. Spring 2017.

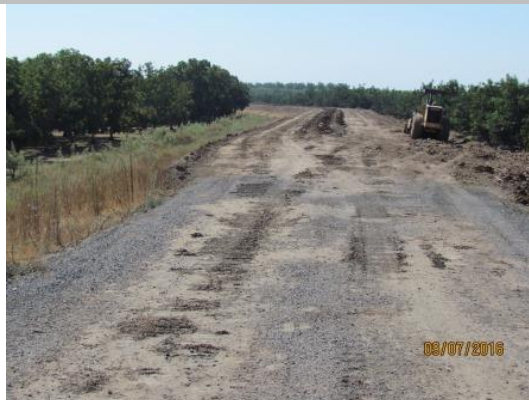
Photo 2 of 2 : SP_2017_MA0007_200_54_20170316_00010.jpg

View of this portion of the levee that is currently under construction that has been degraded and is being brought back to design elevation. Fall 2016.

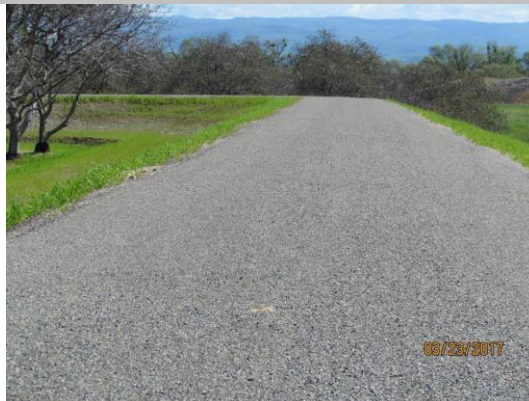
Photo 1 of 2 : SP_2017_MA0007_200_47_20170327_00126.jpg

View of the portion of levee that has been degraded and is being brought back to design elevation and rocked looking upstream. Spring 2017.

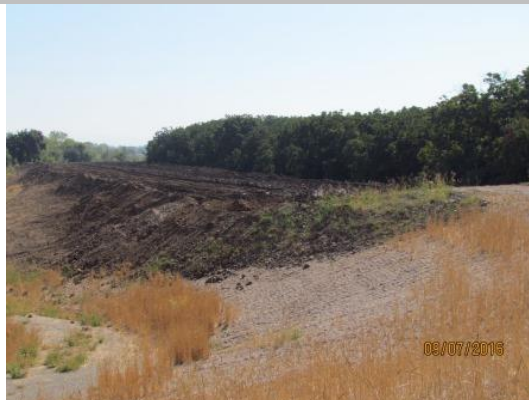
Photo 2 of 2 : SP_2017_MA0007_200_47_20170316_00007.jpg

View of the portion of levee that is currently under construction that has been degraded and is being brought back to design elevation. Fall 2016.

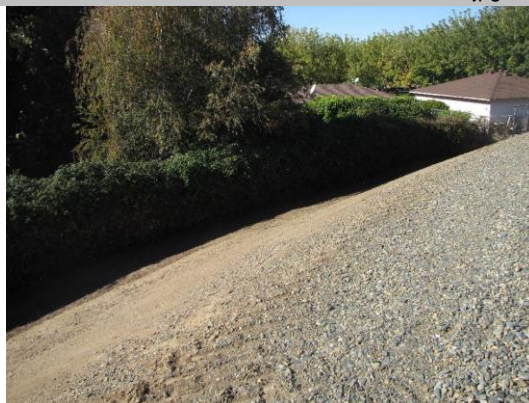
Photo 1 of 3 : UCIP_SP_2017_47991_65953.jpg

View of LS--no signs of crossing or appurtenances are present.
